Performance Contracting

Project: Roof Replacement

How one school district combined ESSER funding with Pennsylvania's **Guaranteed Energy Savings Act** to obtain a full roof replacement for their elementary school.

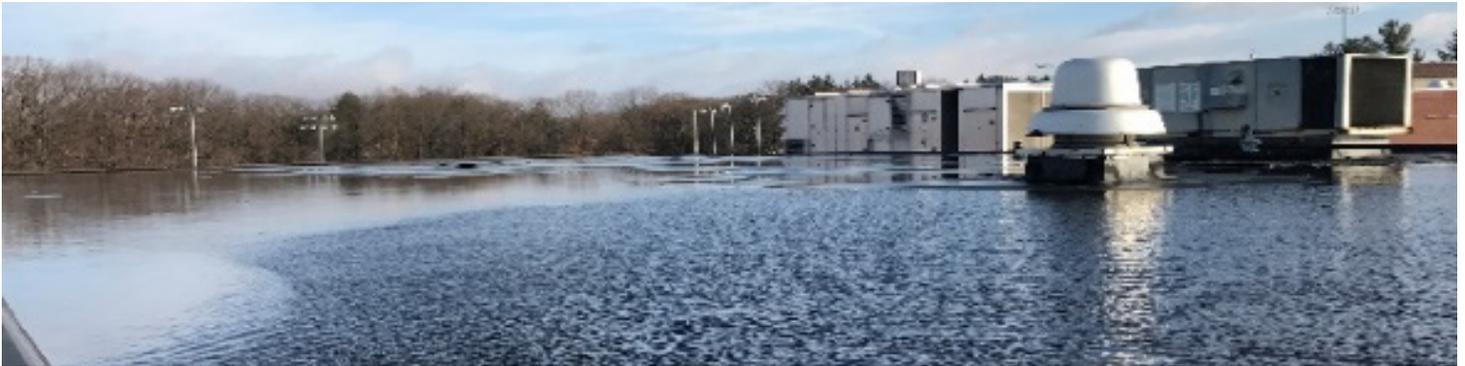
Dunmore Elementary School struggled for many years with malfunctioning roof drainage, as shown below:

Water remained on the roof, creating several inches of standing water (or ice), as well as leaks within the building.

Dunmore's performance contract project tackled the main health risk of the leaking roof, while simultaneously increasing the R-value of the roof. It also included the relocation and addition of drains to address the drainage problems. And, the project involved the replacement of the gas piping which was in poor condition, due to the standing water, as well as age.

While CM3 provides both full roof replacements and rehabilitations, for Dumore School District, CM3 conducted a complete tear-off of the existing roof system, including all sheet metal flashing down to the existing deck.

- » Reuse existing wood blocking to the greatest extent possible to reduce overall cost where possible.
- » Add tapered insulation to improve energy efficiency.
- » Add non-reinforced EPDM membrane.
- » Add new blocking to edges and curbs to meet new insulation heights.
- » Relocate drainage and add more drainage, as needed.
- » Install new aluminum edge around the perimeter of the building.
- » Supply and install new scuppers at the perimeter to aid in drainage.
- » Furnish a 20-year warranty on the roof.
